**DEPARTMENT OF TRANSPORTATION****DIVISION OF ENGINEERING SERVICES**

Contract #: 04-0120F4Cty: SF/ALA Rte: 80 PM: 13.2/13.9File #: 69.28**WELDING INSPECTION REPORT****Resident Engineer:**Pursell, Gary**Address:** 333 Burma Road**City:** Oakland, CA 94607**Report No:** WIR-012951**Date Inspected:** 07-Apr-2010**Project Name:** SAS Superstructure**OSM Arrival Time:** 700**Prime Contractor:** American Bridge/Fluor Enterprises, a JV**OSM Departure Time:** 1900**Contractor:** Zhenhua Port Machinery Company, Ltd (ZPMC), Changxing Island **Location:** Shanghai, China**CWI Name:** Li Jia.**CWI Present:** Yes No**Inspected CWI report:** Yes No N/A**Rod Oven in Use:** Yes No N/A**Electrode to specification:** Yes No N/A**Weld Procedures Followed:** Yes No N/A**Qualified Welders:** Yes No N/A**Verified Joint Fit-up:** Yes No N/A**Approved Drawings:** Yes No N/A**Approved WPS:** Yes No N/A**Delayed / Cancelled:** Yes No N/A**Bridge No:** 34-0006**Component:** OBG CB9.**Summary of Items Observed:**

## WELDING INSPECTION REPORT

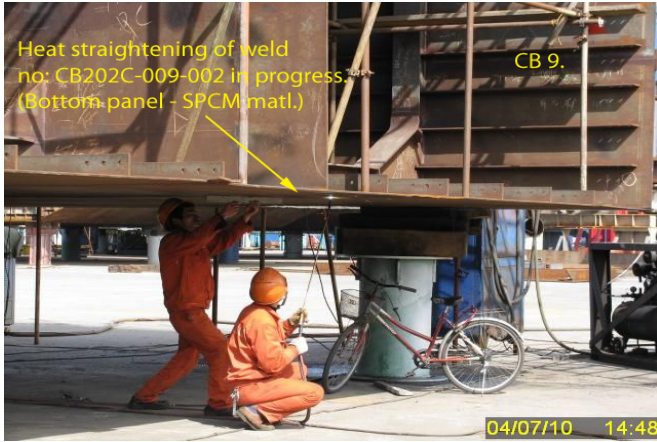
This QA Inspector also observed ZPMC personnel doing heat straightening (HSR) of weld joint no: CB202C-009-002 as per HSR No: HSR1 (B)–7905 Rev-0, DT: 11/18/09. This heat straightening was needed to be done to rectify the weld distortion which was observed as around 5mm to the full length of the weld. QC was identified as Lin Chuan Gang.

Refer attached photos for details.
